# THÈSE

Phases d'initiation et de propagation de la corrosion des armatures du beton  
arme fissure en environnement carbonique ou salin

**Title:** *Initiation and propagation phases of re-bars corrosion in pre-cracked reinforced concrete exposed to carbonation or chloride environment*

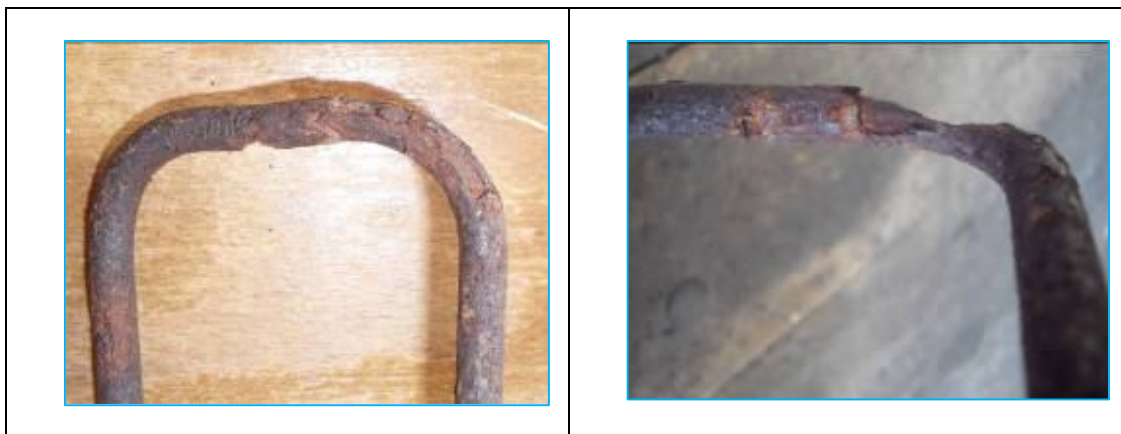
Figure 8. Real corrosion at upper part of stirrups

It must be noted that series A beams were stored in chloride environment with tension face upward (see Fig.1) and A beams were cast with top-cast tensile bars. Therefore, the tensile reinforcing steel and upper parts of link bar in contact with tension re-bars were exposed to chloride spray during storage period. Moreover, the effect of tensioned crack surface and gravimetric access of chloride in cracks led to first corrosion cracks along tension reinforcement, which spread gradually all along beam length. The higher corrosion rate on these zones is due to the higher concentration of chloride. From Fig.7, it is evident that the corrosion state of the upper part of all the stirrups was more serious

than corrosion of the lower part, with many pitting attacks as seen in Fig.8. More importantly, the corrosion of stirrups also developed even those are close to the supports where no flexural cracks exist.

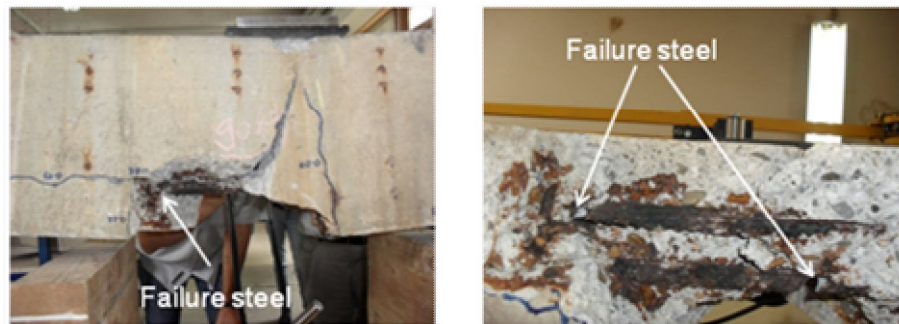
a)

*Figure 10. Failure modes of (a) corroded beam A2CL1-A; (b) corresponding control beam*

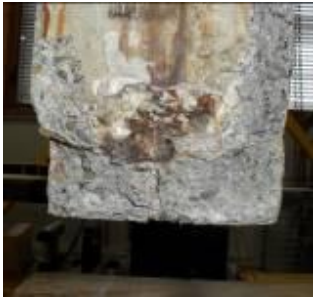
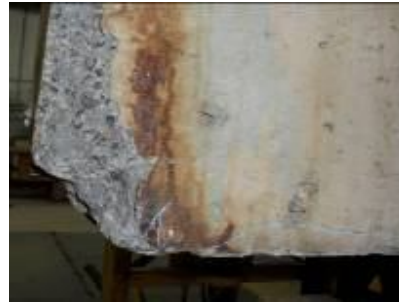
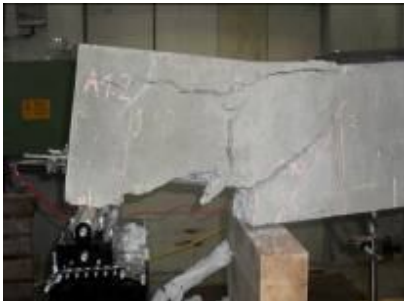
Figure 11. Failure modes of (a) corroded beam A2CL2-B; (b) corresponding control beam

Beams A2CL2-B and corresponding uncorroded beam exhibited the same load-deflection behaviour (fig.9b) but final failure modes were very dissimilar (fig.11). Both of them fail suddenly after the peak load, with really small mid-span displacement. The differences in deflection capacity between them are mainly due to the fact that reference beam collapsed by reinforcement slip and shear interaction, meanwhile the collapse of corroded beam occurred by falling off concrete cover at the support. The longitudinal steel corrosion makes shift in failure type. It should be noted that at the beam end, a big transverse corrosion crack with the maximum width of 1.54mm affected importantly the type of failure of A2CL2-B, spalling off concrete in the corner of beam end as seen in Fig.11a. From the figure 9.b, it can be seen that when the load is below 50% of ultimate load of control beam or 38% of ultimate load of corroded beam, their load-deflection curves are almost similar. Nevertheless, when the load increases further, the difference become clear and corroded beam shows a higher deflection than control beam at the same load level. It should be noted that a shear span to effective depth ratio 2.7 is very close to 2.5, which seems the limit between short beams and slender beams [22]. Therefore, for corresponding control beam the hybrid behaviour combined both beam action and arch

action is anticipated. Indeed, figure 11b presents a slip-bending mode of failure with an incline crack starting from loading point towards bottom face and spalling out of concrete cover near the support. If taking into the loss of cross sectional area of A2CL1-A and A2CL2-B at mid span is 31% and 24%, respectively, in table 3, the experimental results are compared with theoretical predictions for yielding strength of RC beams.

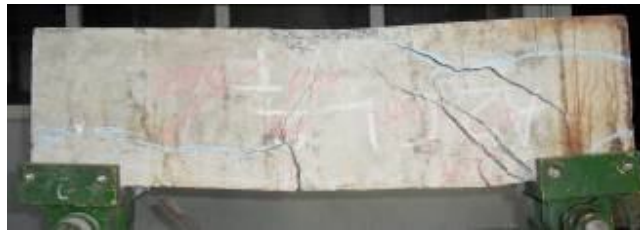
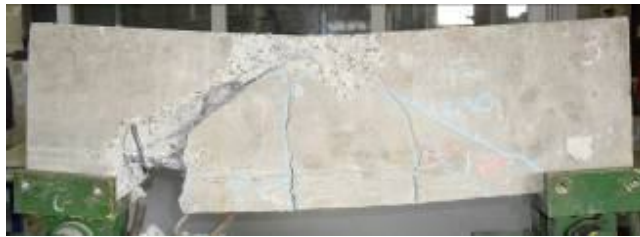
*Figure 13. Failure modes of (a) deep corroded beam A2CL2-A; (b) corresponding deep control beam*

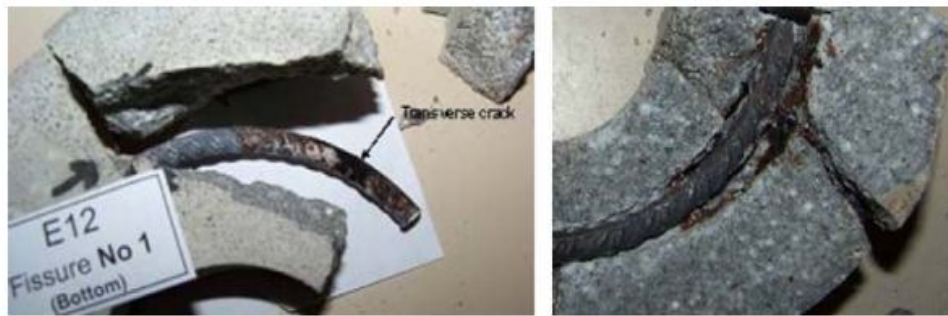
*Fig.III-26. Corrosion initiation at the bottom of cracks and along the rebar-concrete interface by the creation of cracks [22]*

In saline environment, the penetration of chlorides into the cracks is delayed for cracks with an opening less than the critical opening (according to rupture mechanics definition), which corresponds to the end of the interaction phenomenon between the edges of crack (see Fig.3). However, despite this delay, the corrosion mechanism is still the same. The corrosion process initiates at the bottom of the crack when the critical chloride concentration level is reached at this location. A very fast initiation of corrosion is observed whatever the opening of the cracks. The transfer limitation of chloride appears in ranging of 40-50  $\mu\text{m}$ , and therefore the standard limitation for crack width is given in some codes as Eurocode 2 [19] cannot prevent the initiation of corrosion. The corrosion then spreads over a few millimeters (10-15 mm) along the rebar from intersecting point with the crack because of the mechanical

damage to the rebar concrete interface, which is generated by the creation of the crack (see Fig.III-26). Thus, depending on environment conditions, the corrosion can stop or spread leading to the formation of corrosion cracks due to the pressure applied on the covering concrete by the corrosion products.

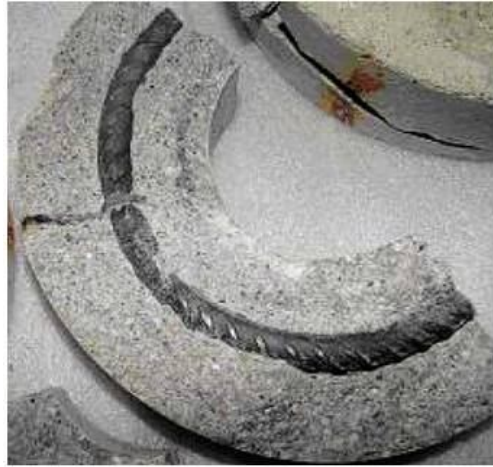
*Fig.III-27. Uncracked sample kept for 500 days in a wetting-drying in saline environment:  
no corrosion or no corrosion crack [22]*

- The corrosion initiates quickly opposite the cracks, even when the cracks have an opening of less than 40  $\mu\text{m}$ . For the uncracked samples, the visual observation shown neither any visible steel corrosion nor any corrosion crack as shown in Fig.III-27.

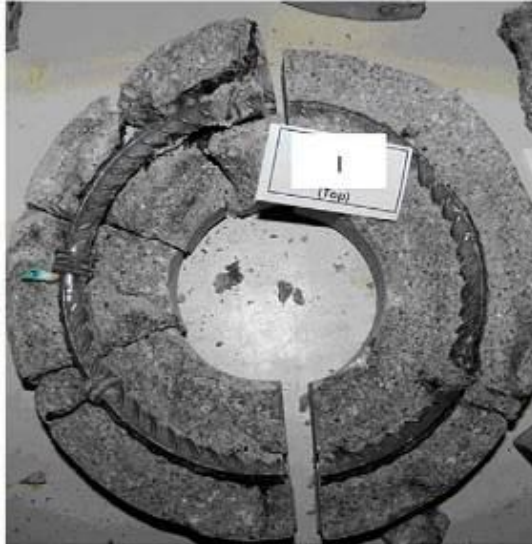
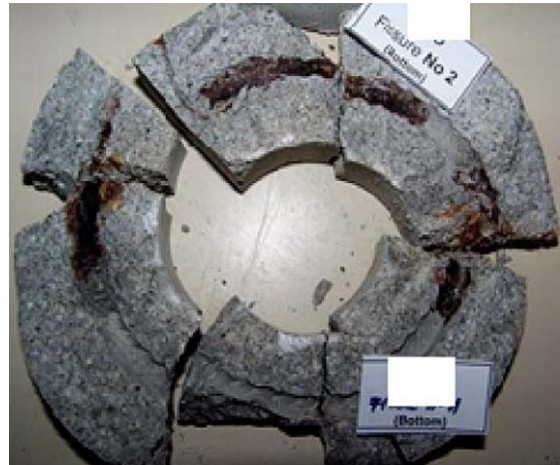
*Fig.III-28. Spread of corrosion along the rebar-concrete interface (duration 500 days) a) from a 28  $\mu\text{m}$  opening crack; b) from a 280  $\mu\text{m}$  opening crack [22]*

- The creation of corrosion cracks is preferably in the bottom of crack where the steel-concrete interface was previously damaged due to creation of mechanical cracks.
- Cracking caused by corrosion is quicker if the pre-existing cracks are wider, which can be explained by the easier access for chlorides and oxygen (Fig.III-28).
- The creation of corrosion cracks appears to be time dependant of the loading level and then of the maximal mechanical crack opening.
- In the long term, when the corrosion has spread, the effect of mechanical origin cracks diminishes.

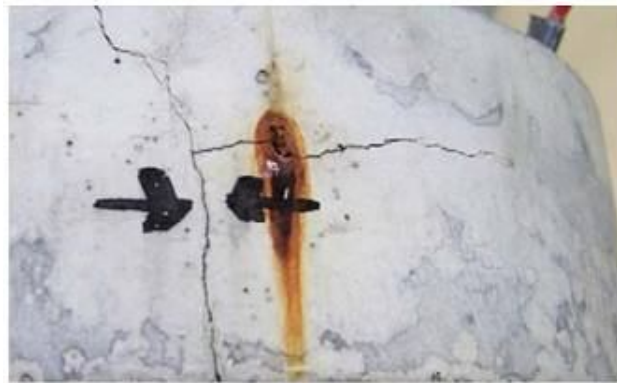
*Fig.III-29. Creation of corrosion cracks from the intersection with transverse mechanical crack with reinforcement (duration 800 days) [22]*

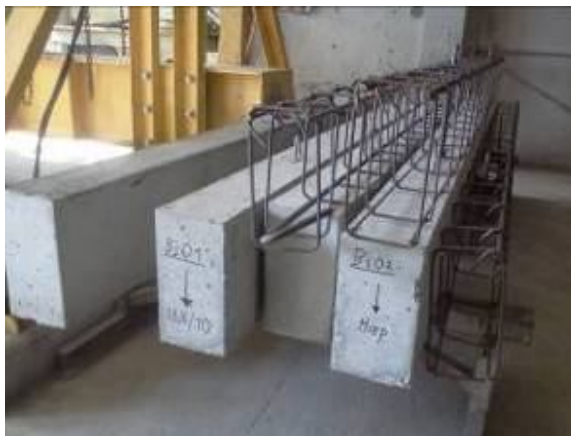
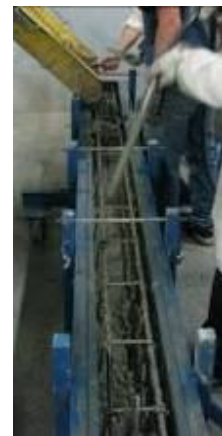
*Figure IV-13. Steel cages and mould used for beams*

Similar to RC beams made in 1984 at the L.M.D.C, 12 RC beams with rectangular cross section of 150mm x 280mm dimension and length of 3000mm were cast in the mould as shown in Fig.IV-13. All the steel cages were prepared in the laboratory. Two types of beam: A beam and B beam as displayed in Fig.IV-14:

- ✓ A beam type (6 samples): each of beams was reinforced with two deformed reinforcements of 16mm diameter in tension zone and two deformed reinforcements of 8mm diameter in compressive zone. The stirrup was 8mm diameter deformed steel bars, 220mm center to center spacing along the whole length of beam. The cover thickness to stirrups was 40mm. Contrary to previous long-term program presented section IV.2, A beams were casted in “classical” way: i.e. tension reinforcement corresponds to bottom reinforcement.

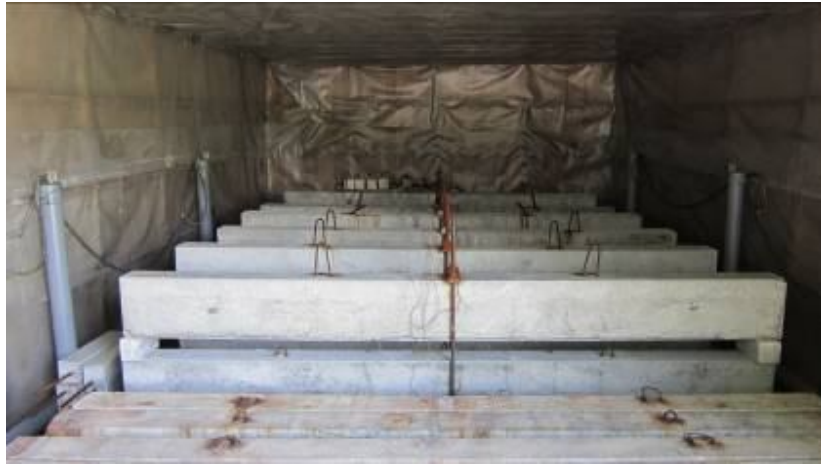
*Figure IV-17. Exposure conditions of beams*

When exposing to chlorides, it should be borne in mind that the gravity must also be considered. In fact, classic cracks due to bending moment located in the bottom part of a beam (positive bending moment) do not have the same risks of corrosion as those that arrive in the upper part (negative bending moment). The cracked upper parts (negative bending moment) are directly exposed to more severe limit conditions during wet periods (accumulation of salt water on the upper surface with increase in chloride content, gravitational filling and then drying of the cracks) (Fig.IV-18). This lead to the chloride content at steel bar depth on negative moment surface reaches quickly the threshold value and the corrosion will spread speedily from the intersection of mechanical cracks with the rebars.
